VERMILION HARBOR, OHIO

CONDITION SURVEY REPORT

STUDY OF THE IMPACT OF THE OFFSHORE BREAKWATER ON

U.S. ARMY CORPS OF ENGINEERS
BUFFALO DISTRICT
1776 NIAGARA STREET
BUFFALO, NEW YORK 14207

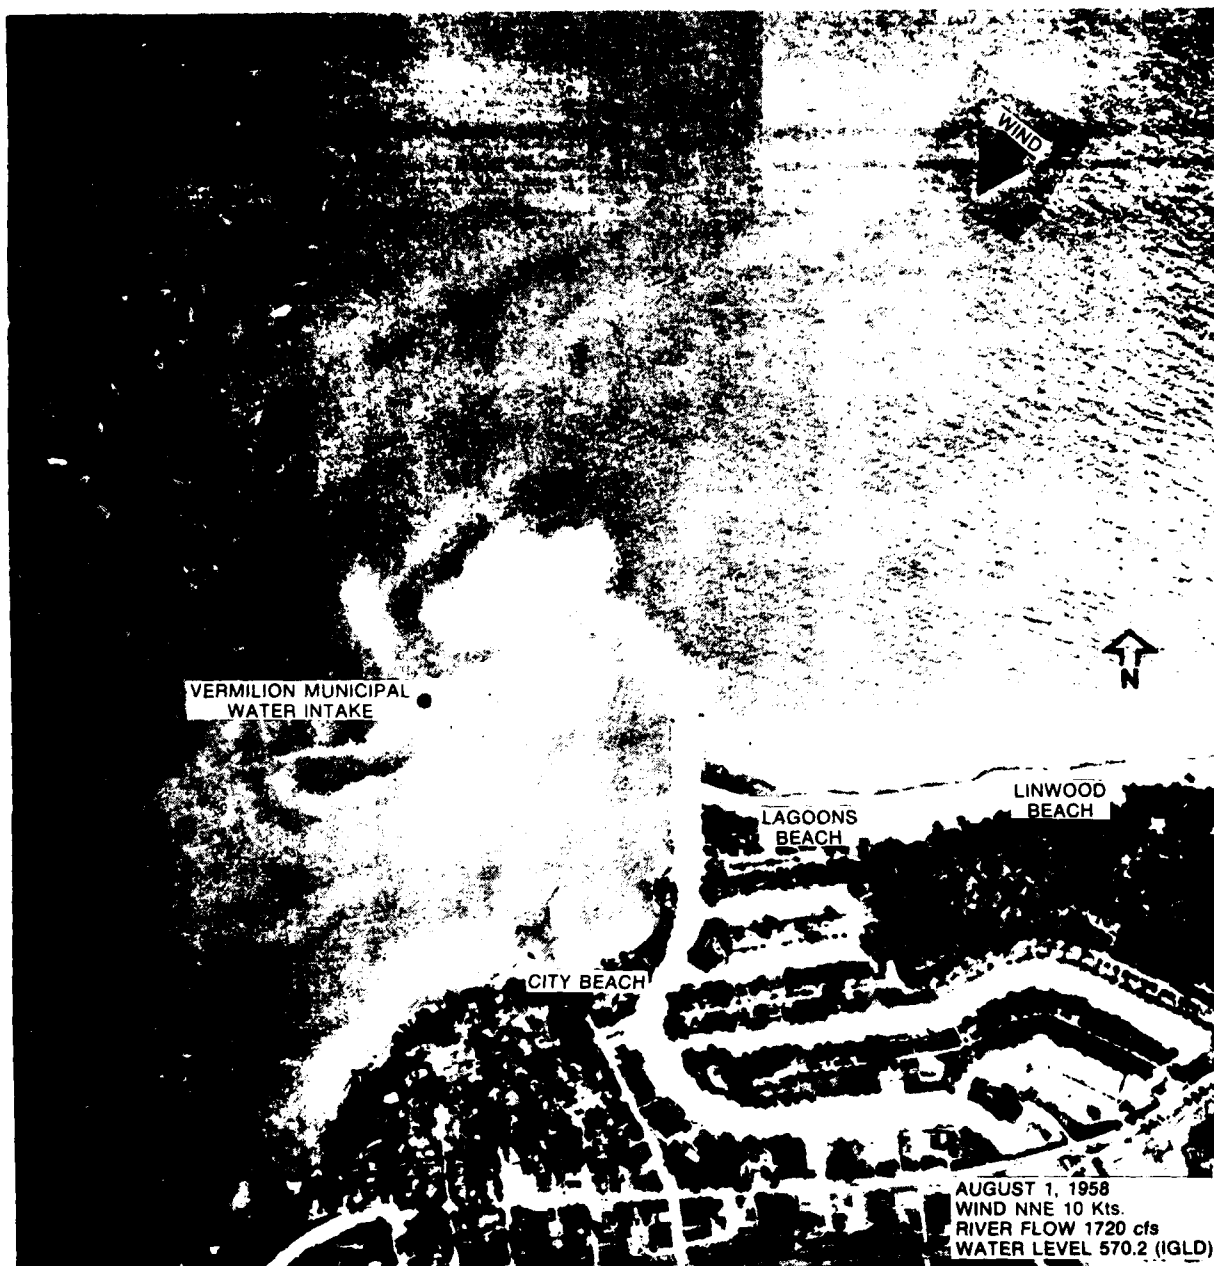
Photo 4 • SHOWS SOME INFLUENCE ON WATER INTAKE.

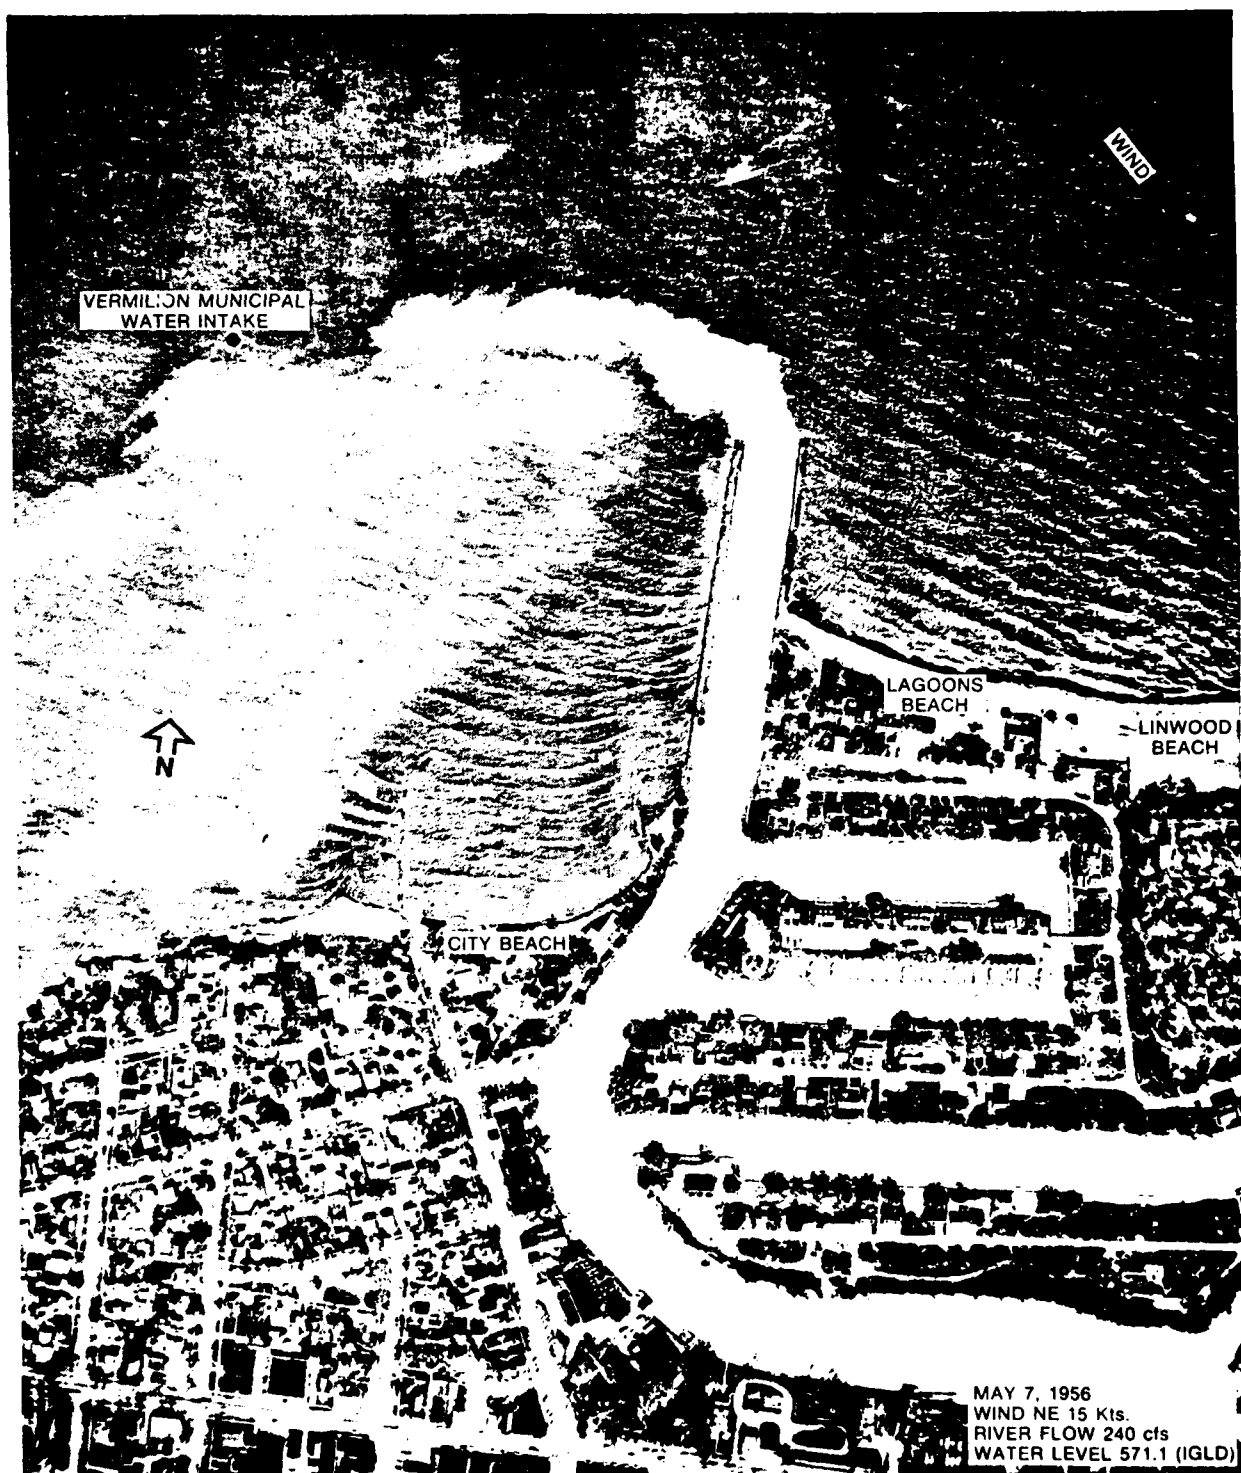
Photo 5 - RIVER PLUME DEFLECTED SHARPLY BY STRONG NORTHEAST WIND

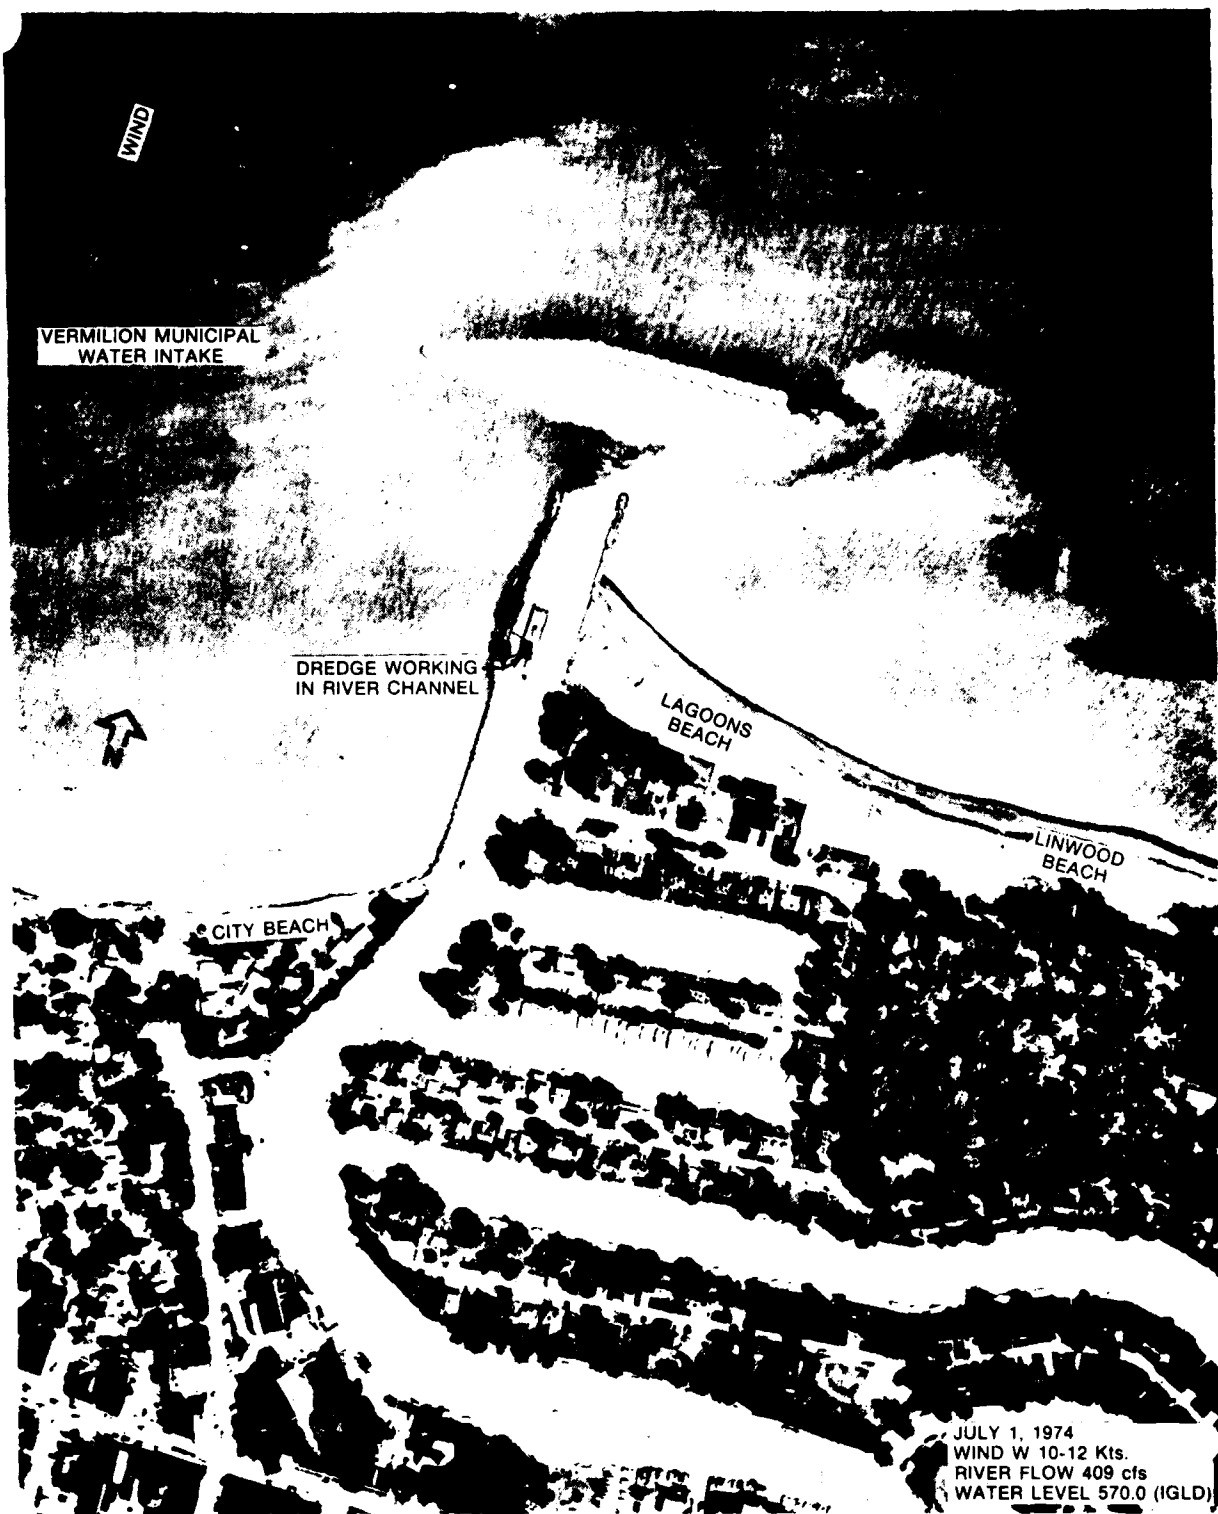
West Through Southwest. Winds from these directions are the prevailing winds. Photos 6 through 8 show the effect on the plume by these winds in pre and postbreakwater periods. Photo 7 shows the Vermilion River water moving essentially offshore (north) during moderate southwesterly winds. A comparison of Photos 7 and 8, taken during similar wind conditions, indicates that the breakwater appears to force river water along the Lagoons and Linwood swimming areas.

Photo 6 • BREAKWATER DEFLECTS CURRENTS TOWARD THE EAST - SOME INFLUENCE ON LAGOONS AND LINWOOD BEACH.

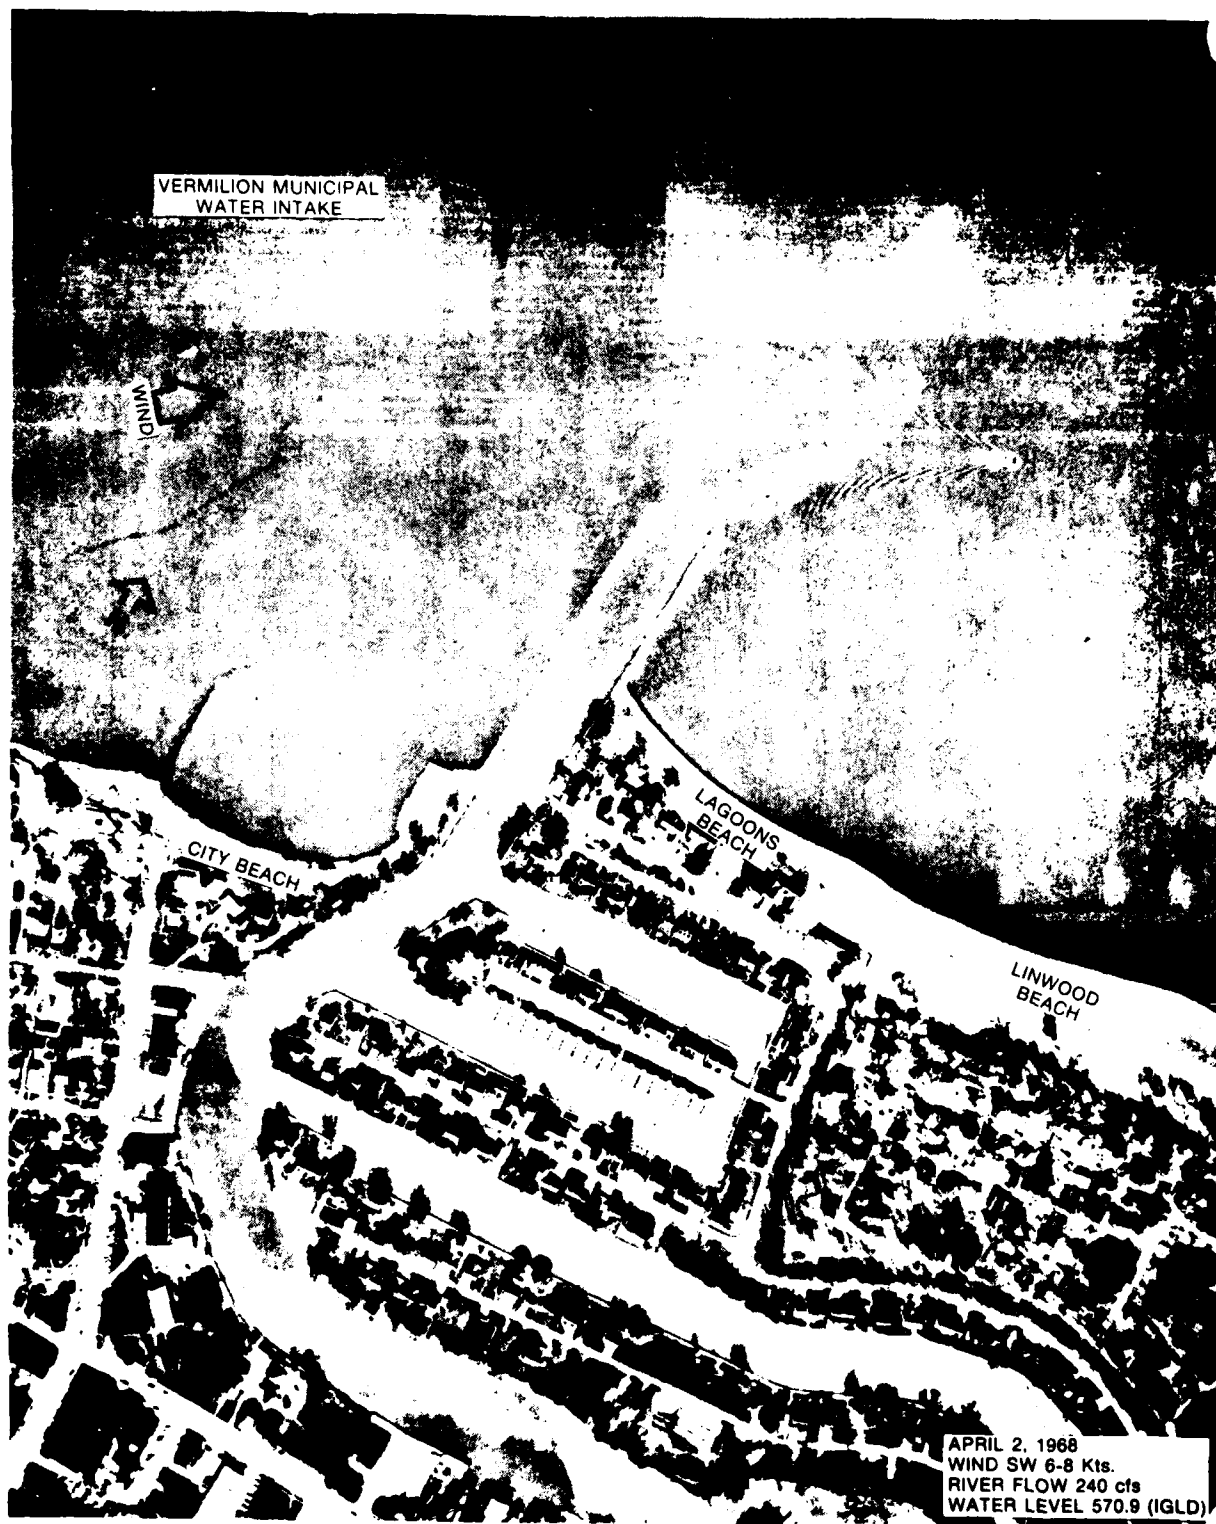
Photo 7 • SHOWS RIVER PLUME MOVING NORTH UNDER SOUTHWEST WIND.

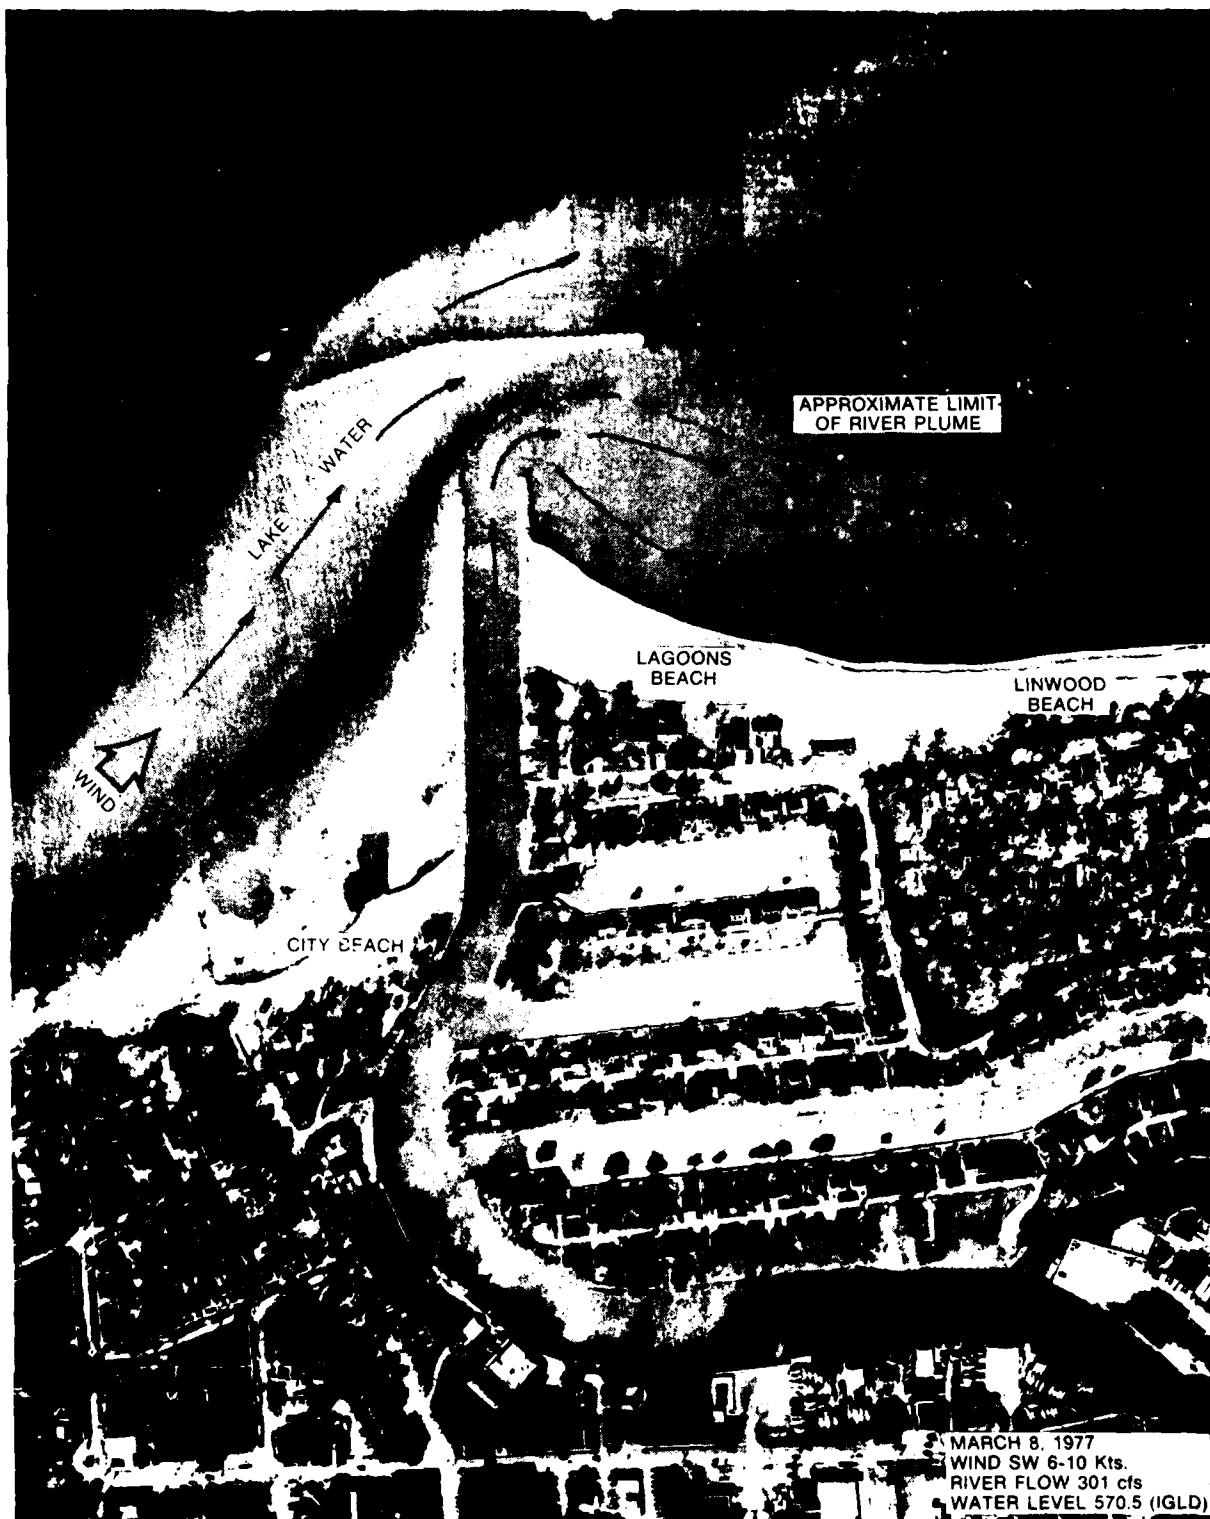
Photo 8 • SHOWS RIVER WATER MOVING ALONG BEACH AREAS.

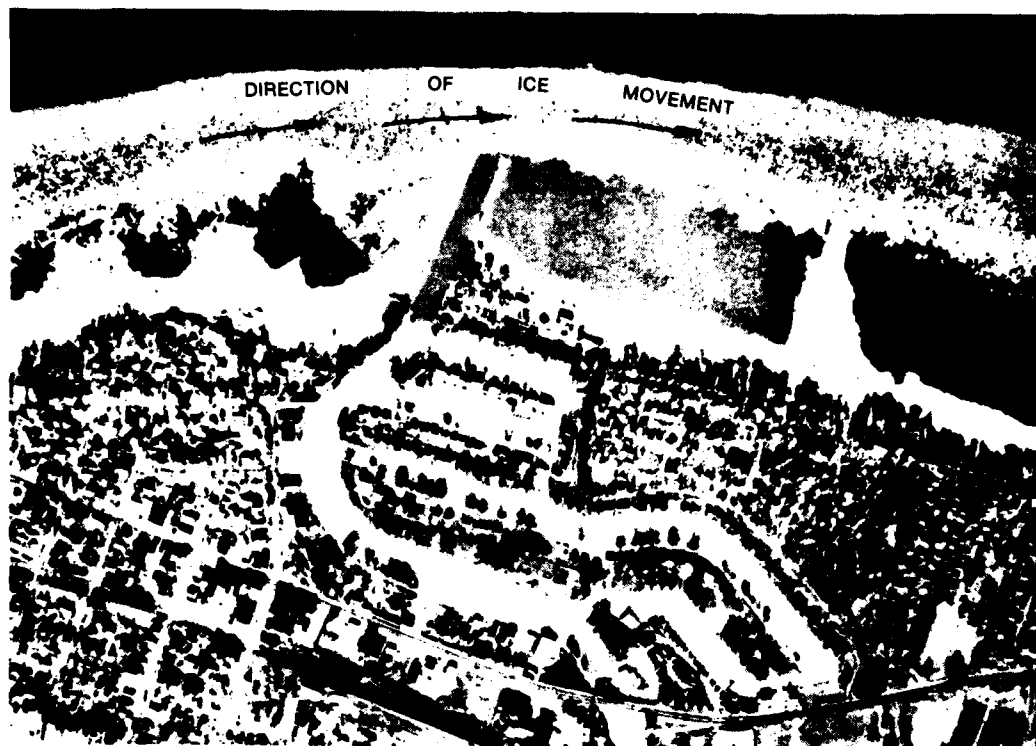
Photo 10 • PHOTOGRAPH SHOWING ICE MOVEMENT AT VERMILION (Jan. 25, 1962)

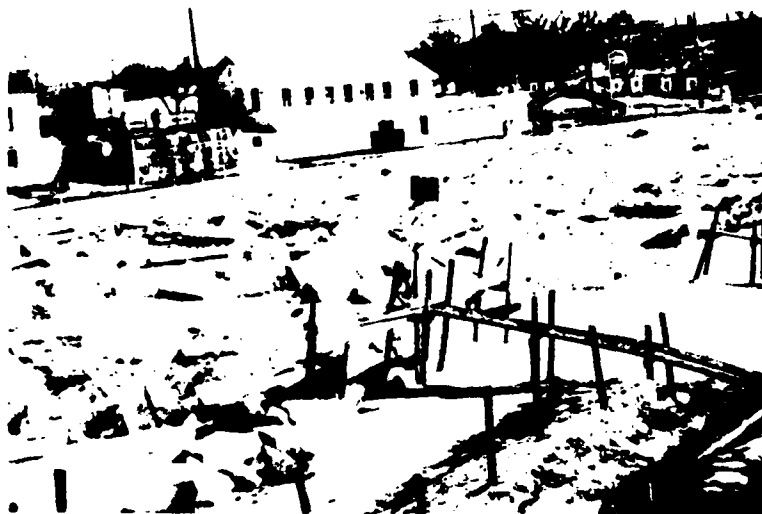
Photo 11 • TYPICAL ICE JAM ON VERMILION HARBOR (March, 1963)

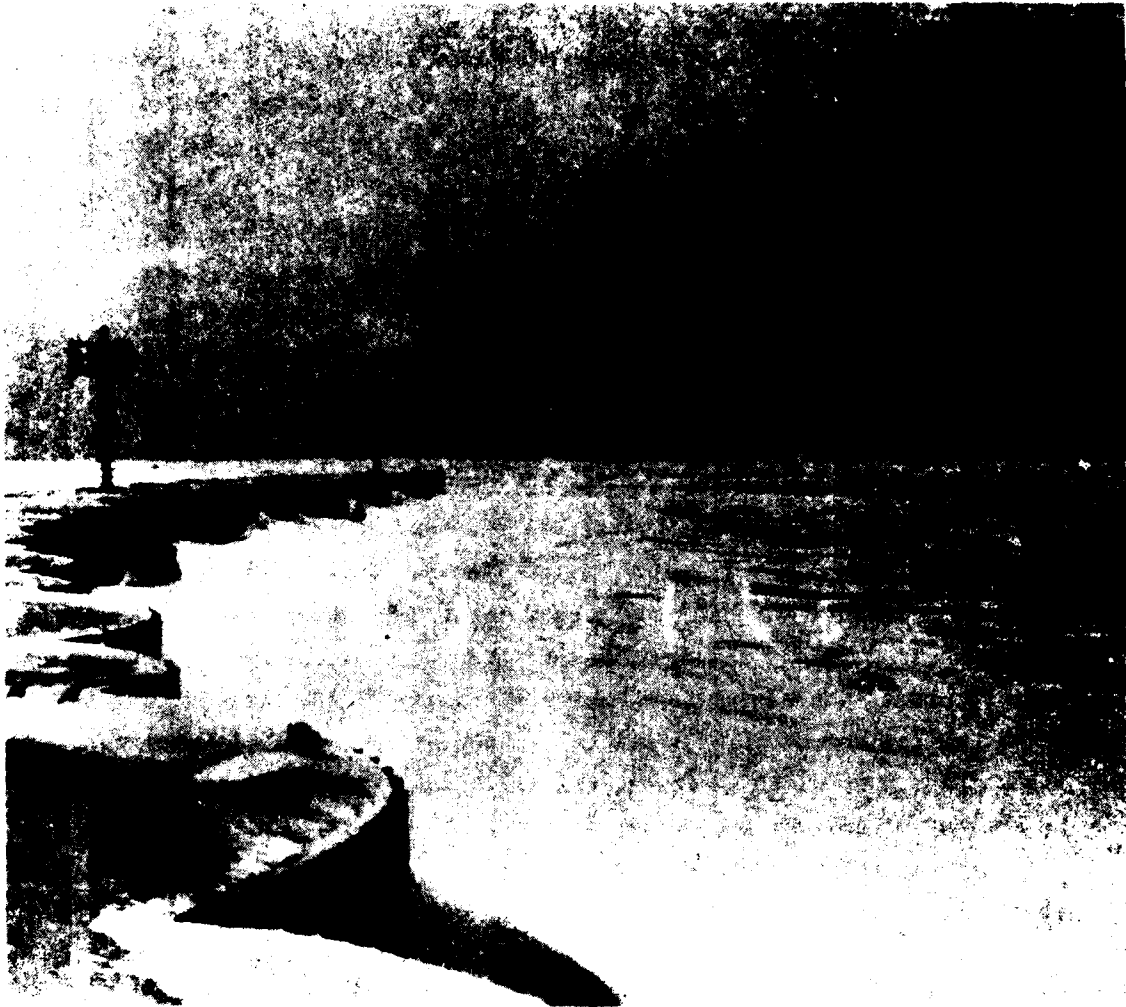
Photo 12 • SHEET ICE BETWEEN BREAKWATER AND PIERS (Jan. 30, 1978)

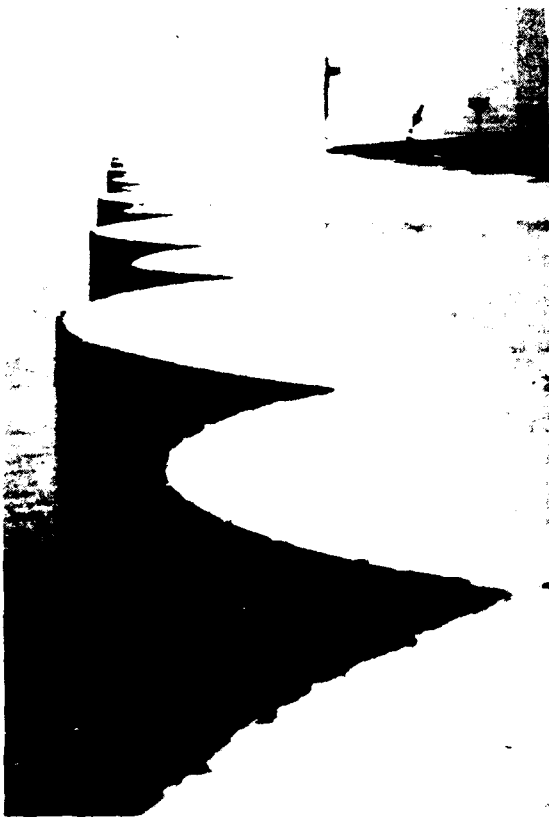
23 • VIEW LOOKING EAST ALONG LAKE SIDE OF BREAKWATER SHOWS MACHINE-LIKE GEOMETRY OF INTERLOCKING ARCS OF SHEET PILING. HUMAN FIGURE (SEE ARROW) INDICATES LARGE SCALE OF BREAKWATER.

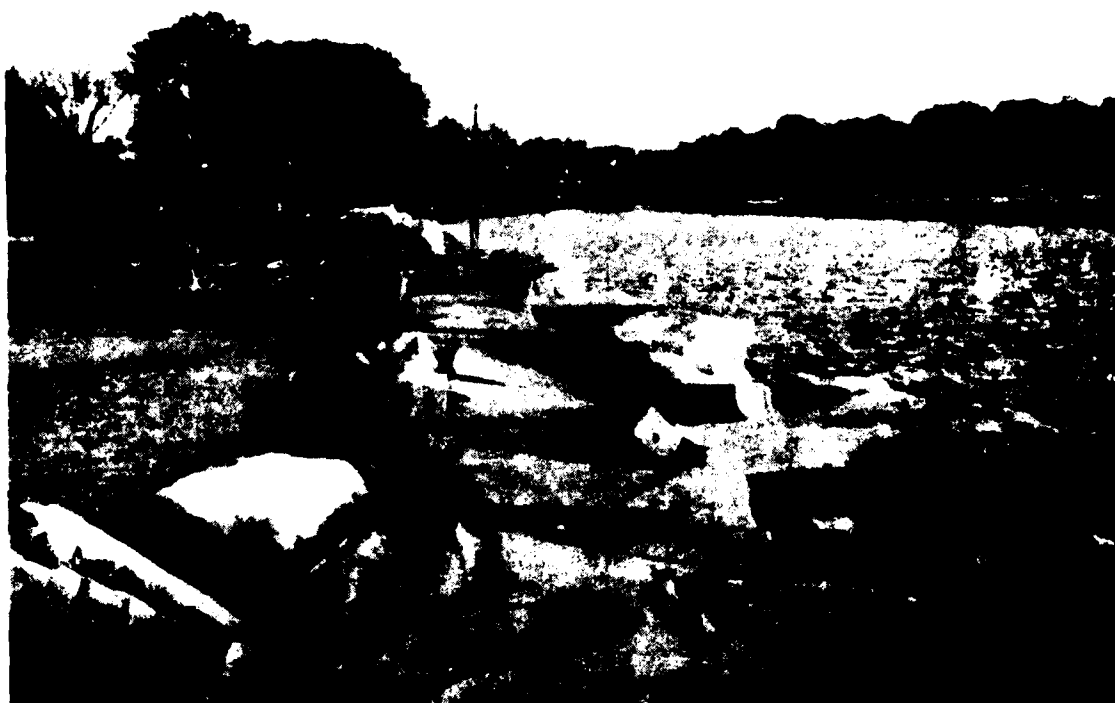
29 • EAST PIER LOOKING TOWARD SHORE AND UP THE RIVER CHANNEL TO RIGHT OF CENTER. RANDOMLY PLACED, IRREGULAR SIZE OF INDIVIDUAL STONES GIVE AN INFORMAL APPEARANCE TO PARALLEL PIERS.

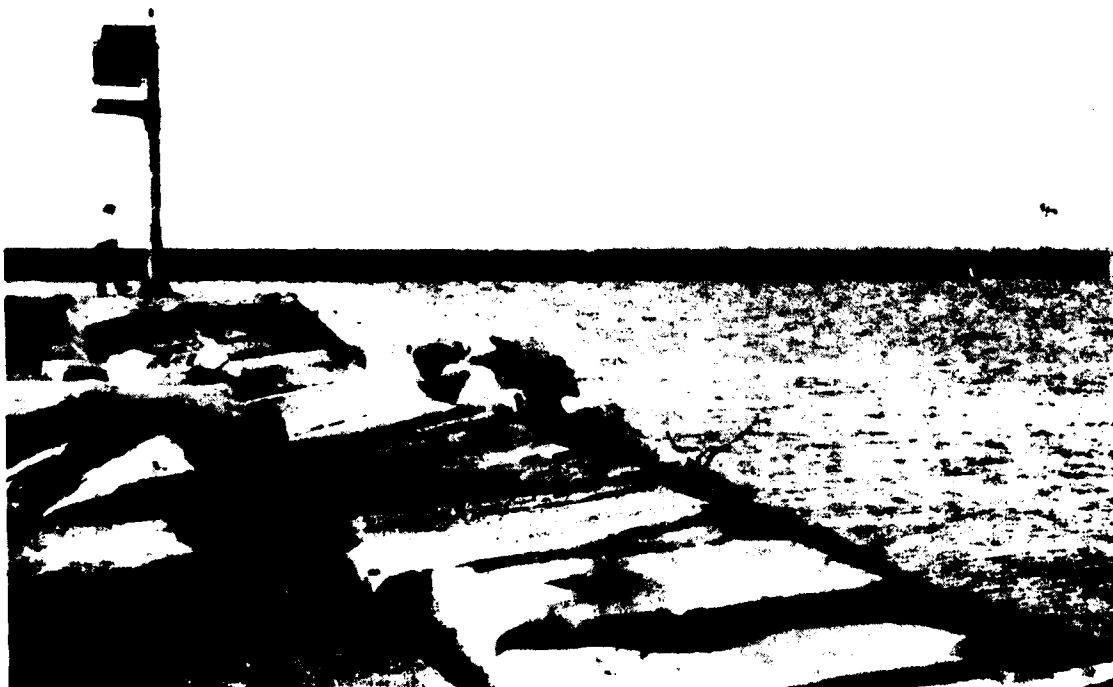
30 • EAST PIER AND EAST END OF BREAKWATER. CONSTRUCTION MATERIALS CONTRAST QUARRIED STONE WITH STEEL SHEET PILING. SCALE OF MATERIAL MODULES IS EVIDENT WHEN RELATED TO HUMAN FIGURE IN PHOTO.
